Number 21, 2025

Welcome to the Welsh Stone Forum Newsletter 21. Although the Forum had a slightly reduced programme for 2024, in part as a product of the cuts to Mineralogy & Petrology section staff at Amgueddfa Cymru - National Museum Wales, I hope that you still enjoy the reports and articles. Thanks are due to all those involved in planning and leading these events. We have held joint meetings with other societies in the past, and our joint meeting for 2024 was a study day in October with the Church Monument Society at St David's Cathedral. This provided an excellent opportunity to view and discuss the interior of the cathedral with those with complimentary interests and knowledge. An enjoyable time was had by all! Although the CMS activity is not exclusively in Wales, we hope that a similar day might be programmed with them in the future. We would like to thank Heather James of the Society for producing such an excellent report of the day.

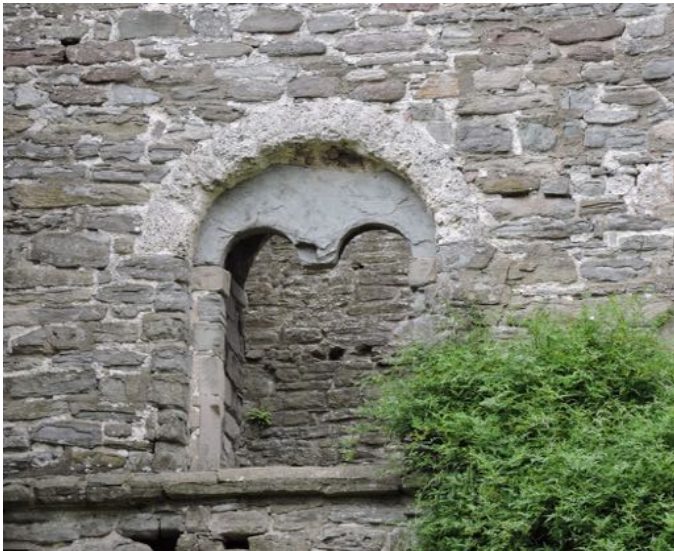
Fig. 1. Tufa, Hay Castle keep © Michael Statham

It was soon found that tufa was used in the window recesses of Bronllys Castle (Clarke 1866) not far from Talgarth (SO1491 3467). According to Scourfield and Haslam (2013), was built late 12th century with the tower added soon after 1221, the keep in the early 13th century to which an upper floor was added in the early 14th century. Tufa was also used in the round-headed Norman window on the second story of Hay Castle keep, built c.1200 (Fig. 1).

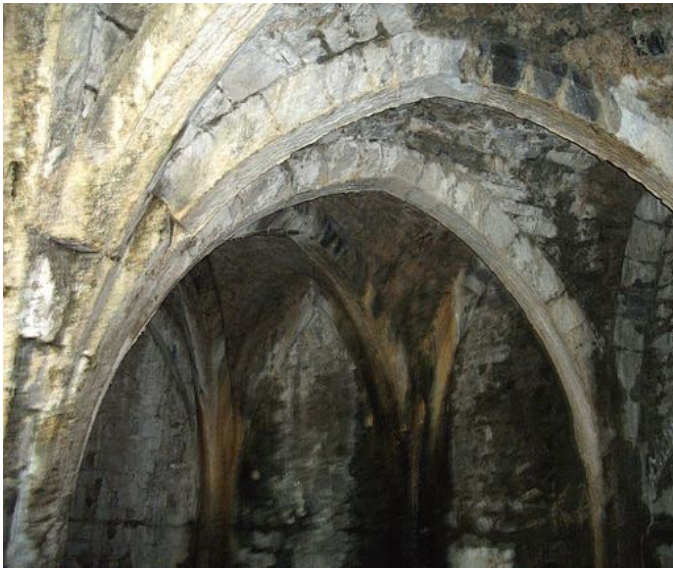
Fig. 5. Ceiling. © Michael Statham

ure 2 there is a subterranean chamber that has survived. It is accessed by a small entrance between rocks (Fig. 4) and comprises a polygon of twelve sides with a central column with corresponding facets branching into twelve fan ribs which support the roof (Fig. 5). The ribs are of Carboniferous Limestone, but the infilling is of tufa, almost certainly sourced locally as there are known tufa deposits associated with springs from the limestone in the adjacent upper Taff Valley.

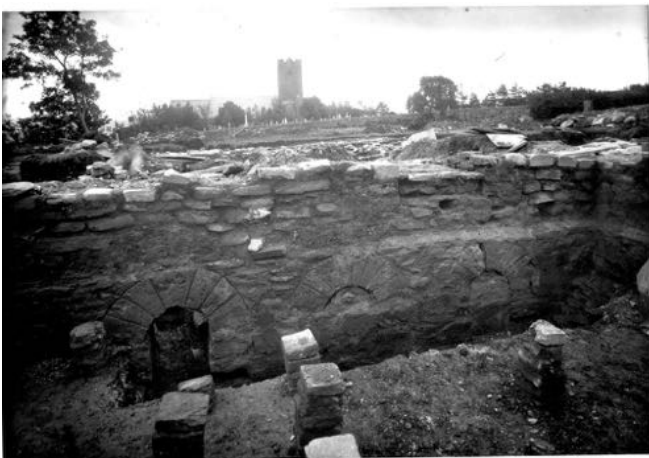
Fig. 6. Tufa voussours, Gelligaer Roman Fort. © W. Clarke, Llandaff.

It is well known that the Romans liked to use tufa in their buildings, and a particularly well-preserved example was found during excavations at Gelligaer, (Ward, 1909), which comprised three voussoirs in the bath house, a photograph of which has been found in Clarke's archive, (Fig. 6). Tufa was also found at a Roman site at Penydarren Park, Merthyr Tydfil (James, 1906). At both sites, which date between around the late 1st to early 2nd century, the tufa was almost certainly sourced from the same locality at that used later at Morlais castle.

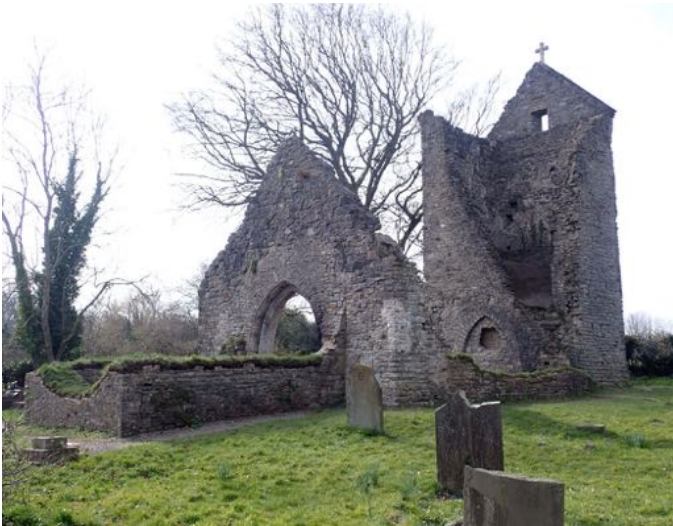
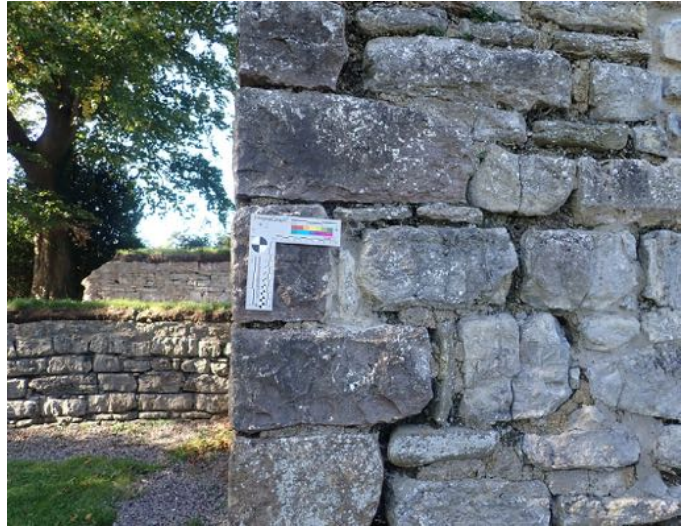
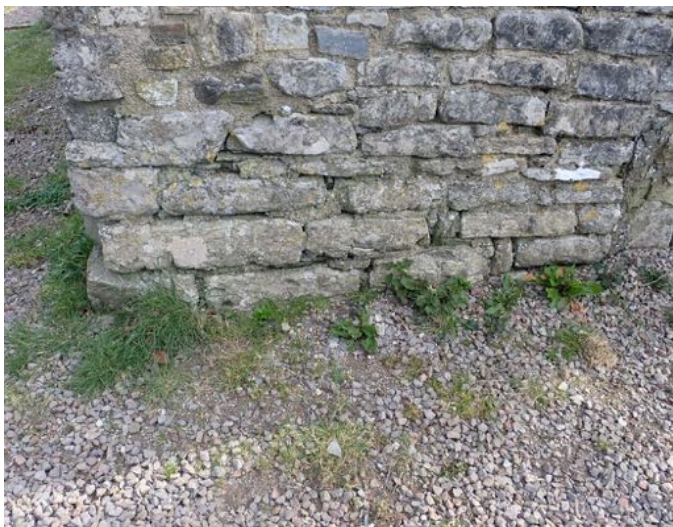
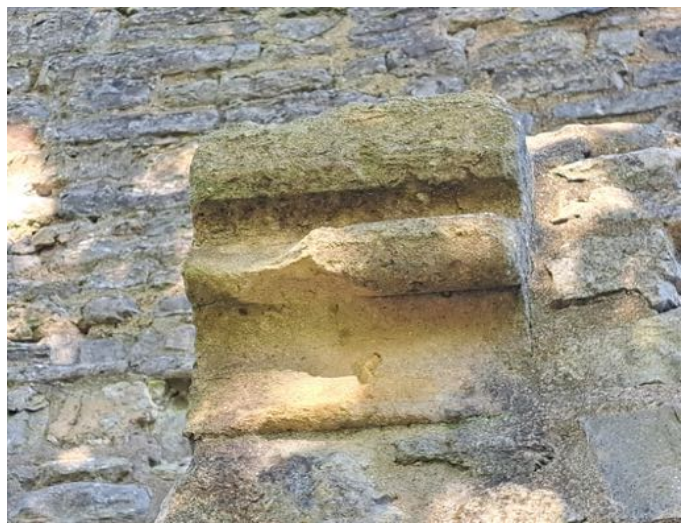
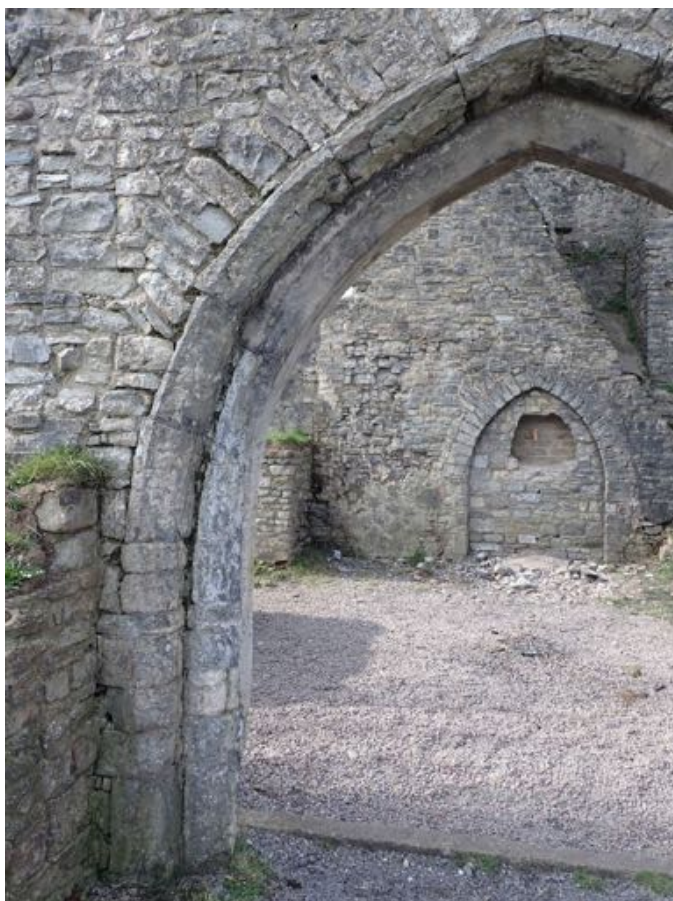
Fig. 1. (top left) General view of St Mary's Caerau, from the NE, showing ruined state. Fig. 2 (left middle) Lias limestone blocks in the base of the west wall of the tower, these are c 15cm x 60cm. Fig. 3.(bottom left) Chancel arch worked from Lias limestone, basal 5-6 blocks, laid with horizontal bedding, the arch with faces bedding. Tower arch of Lias blocks seen in the background. Fig. 4. (top right) southeast corner of nave showing limestone quoins inserted by Pritchard. Long Lias blocks on the east wall of the porch seen in background. Fig 5 (middle right) C19 Bath Stone corbel from the west side of the porch roof.

Although now totally ruined, the original medieval fabric of this building can be seen to be composed exclusively of variably coursed Lias Limestone (Fig 2). Blocks are of differing size, with the largest more coursed stonework having blocks not exceeding 20 cm high by 70 cm wide. These are particularly prominent in the base of the tower, and then again half-way up on the south side, however, most blocks are smaller than this. Although the porch was rebuilt in the 1885 renovation, the large blocks of Lias are considered to be of medieval origin as they correspond in size to those in the tower. Similarly, all remaining evidence of doorways is of Lias; blocks in the base of the south doorway, and the tower doorway. No evidence of the nature of the chancel windows remain (as the walls are only c. 1.2m high).

The chancel arch is of simple design, with blocks laid 'on the bed' in the lower portion but face bedded in the upper part to provide longer pieces of stone than bedding permits (Fig 3). The Carboniferous Limestone in the fabric, particularly noticeable as quoins in the chancel (Fig. 4), date from Pritchard's rebuilding of the chancel. Other stone includes rubble that from rebuilding in the 1960s, with Carboniferous Limestone donated by Wenvoe Quarry, infill of doorways in Pennant Sandstone, and pebbly red sandstone (presumably from the local Lower Old Red Sandstone). During Pritchard's renovation all medieval dressings were replaced with Bath Stone (Fig. 5) (Lewis & Jay, 2006). The composition of the font, described as having 'a cylindrical bowl on a shaft of like

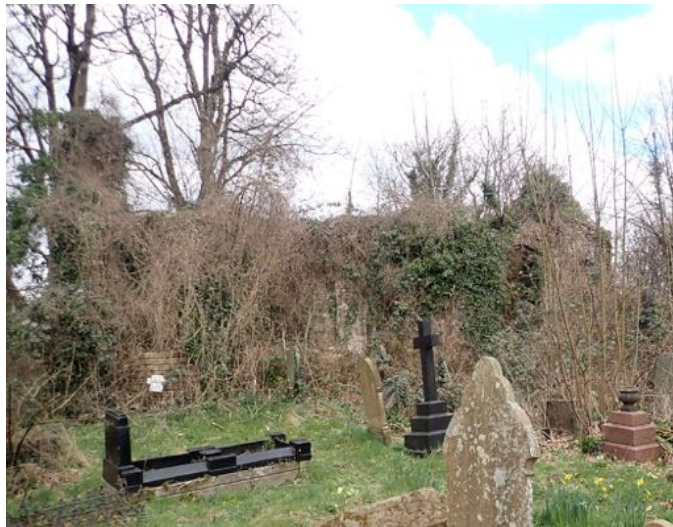
The fabric of the building is of local Carboniferous Limestone rubble work (Fig. 8). Dressings are limited to the late 13th - mid 14th century trefoil headed lancet window located in the east wall, worked from Sutton Stone. (figure 9). Sutton Stone quoins are also present at the base of the northeast and southwest corners of the north wall. The three C17 windows in the south wall, have simple dressed openings of Carboniferous Limestone blocks with Pennant Sandstone sills.

Fig. 8. (bottom left) fabric of Chapel Tal-y-garn composed of Carboniferous Limestone rubble work, with red staining.
 Fig 9. (bottom right) C13/C14 trefoil east window worked from Sutton Stone.

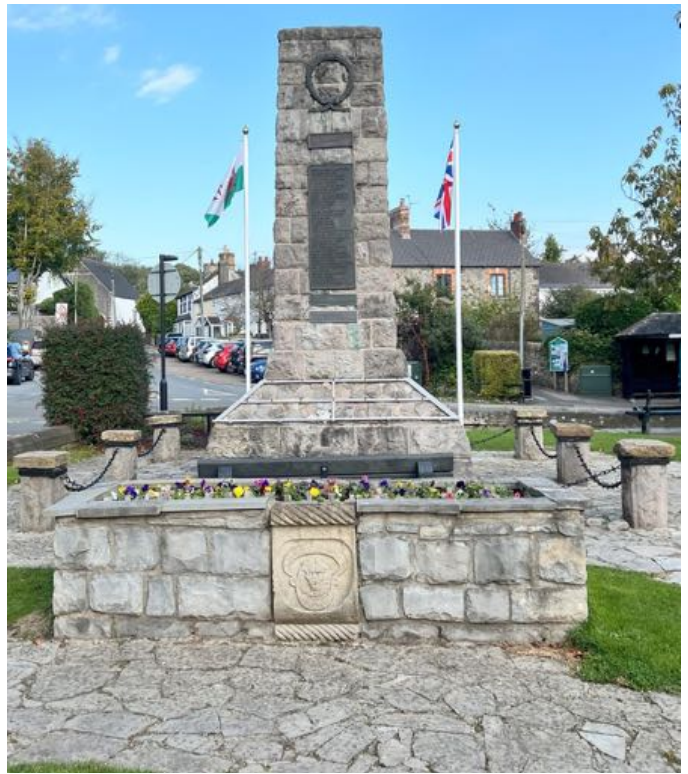
Fig.1. WWI memorial cross, Dinas Powys.

Clarke's Day Book records for the job show that the monument was built entirely of Carboniferous Limestone supplied by the St Andrews Quarry Company. The Purchases Ledger for the period shows the cost of the stone was £37.9s.11d. The names of the fallen were to be on bronze tablets made by W. A. Baker and Co., Newport. There is no mention of crazy paving.

In 1947 Clarke was commissioned to make additions to the memorial. A poorly preserved drawing dating to this time has survived from which it is presumed that this is when the chain-link barriers, crazy paving surround and raised flower bed were added, together with additional WW2 bronze tablets. The crazy paving is from the Bull Cliff Member of the Blue Lias.

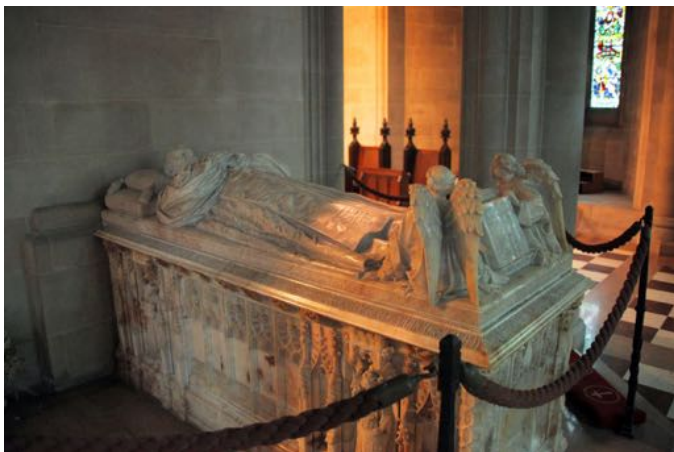
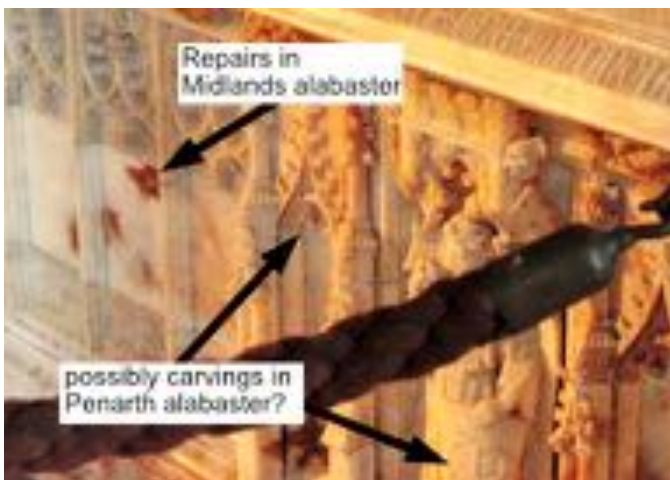
Fig. 1 Cenotaph of Henry Yates Satterlee, Washington National Cathedral. *Fig.2* Close up of alabaster in *Fig.1*. Both images Tim Evanson, CC BY-SA 2.0 <<https://creativecommons.org/licenses/by-sa/2.0/>>, via Wikimedia Common.

A photograph of reasonably high resolution found online is shown in Figure 1. At first sight it is difficult to decide if there is any Penarth alabaster present. However, zooming in to detail of the tomb, (Fig. 2), two types of alabaster are evidently present. The carvings do look as though they might be Penarth alabaster, but nearby there appear to be panels (possibly repairs) of Midlands alabaster. Without much higher resolution photographs, it is impossible to confirm this. The effigy of Satterlee appears to be carved from one piece of stone. As Penarth alabaster is not known to have been obtainable in such large pieces it is considered that the alabaster for the effigy is from a different source.

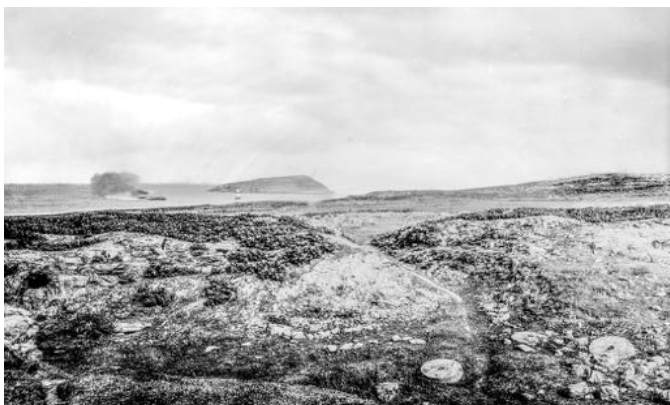
Fig. 1. Three millstone on undulating ground at Parc Trwyn-Du, NE of Penmon Priory, Anglesey. © W. Clarke archive.

The archive of the firm of W. Clarke of Llandaff, sculptors, monumental masons and general builders, contains a photograph dated c1902 (Fig. 1) which shows three millstones on open ground near to Penmon point, indicating that there was a millstone quarry in the vicinity. As far as can be determined without visiting the area, the location from which the photograph was taken appears to be close to an outcrop of sandstone [marked on BGS geological map as sandstone within the Loggerhead Limestone Formation] centred on SH 636 810.

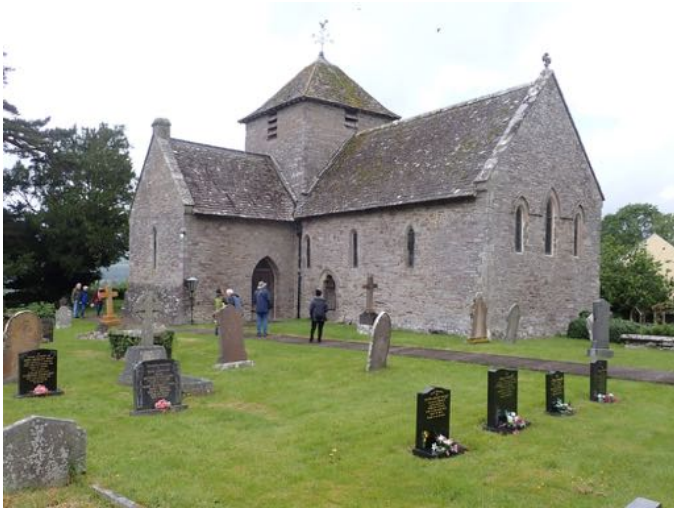
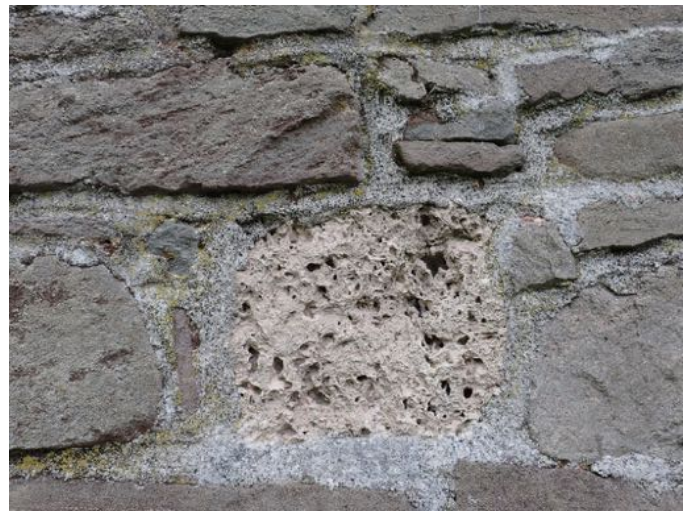
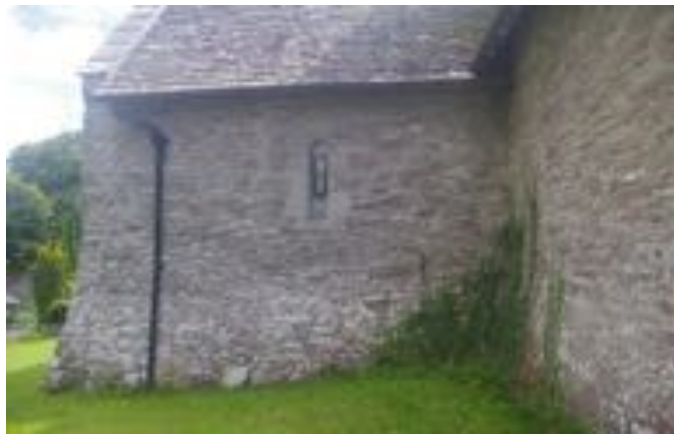
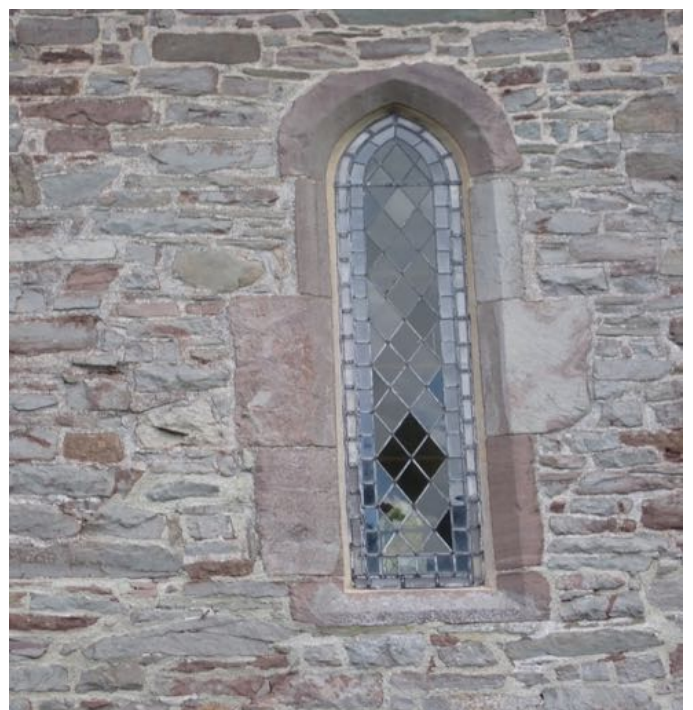
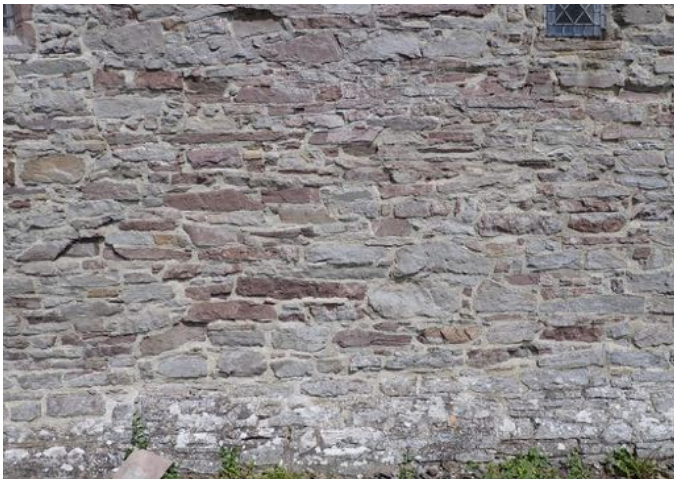
Fig. 1. (top left) St. David's Llanddew, viewed from SE. Fig. 2. (middle left) west wall of vestry showing the west wall of the vestry showing extensive rebuilding. Fig. 3. (bottom left) fabric of chancel wall composed of red and grey rubblework sandstones. Fig. 4. (top right) Rare block of tufa in fabric. Fig. 5. (bottom right) Window, south chancel red and mottled sandstone, replaced during renovation work.

A 1995 CPAT report (CPAT, 1995a) describes this church as a cruciform structure with a central tower. The current building appears to date from the C13, with rebuilding in C17 (addition of the tower 1629) and both C18 and C19 restoration. The latter phase included replacement of nave windows and the addition of the porch (Fig. 1).

The group started by inspecting the fabric of the building. This was seen to be predominantly rubblework, although locally more coursed. It is composed of homogeneous, grey, red and buff Sandstone (Figs 2 & 3). Occasional blocks of pebbly sandstone and tufa (Fig. 4) were also

found; the latter suggesting an origin at the boundary between the RMF and SMF (see Horak, Newsletter 15 for more detail on this context). The nave window dressings were replaced during restoration work in red and grey sandstone, similar to that of the fabric (Fig. 5) but of post-medieval origin. The roof was noted as of red/grey stone tiles; those in the chancel and transept date from C19 restoration work. These may be derived from the St Maughan Formation.

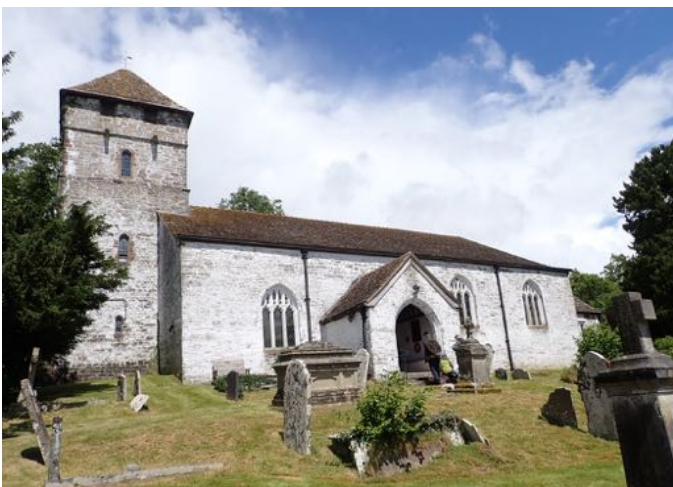
The group then moved northeast to **St. Matthew's Church, Llandefalle** (Fig. 6) CPAT (1995b) documents it as having C13 or C14 origins (north nave wall, tower and south doorway) with the remainder (chancel, south aisle and porch) of C15. They record little C19 restoration work. The church is now limed (including the east window!), which precluded close examination of the stone, but earlier images show it to be composed of dominantly of thinly bedded grey-green sandstone with minor red/brown sandstone. The grey-green stone is still

Fig. 6. (top left) St Matthew's church, Llandefalle, viewed from the south. Fig. 7. (bottom left) south doorway, of streaky maroon sandstones, with inset detail showing cross bedding. Fig. 8. (top right) C13 font of red banded sandstones similar to that seen in the south doorway. Fig. 9. (bottom right) faux slate monument with inset showing sandstone composition.

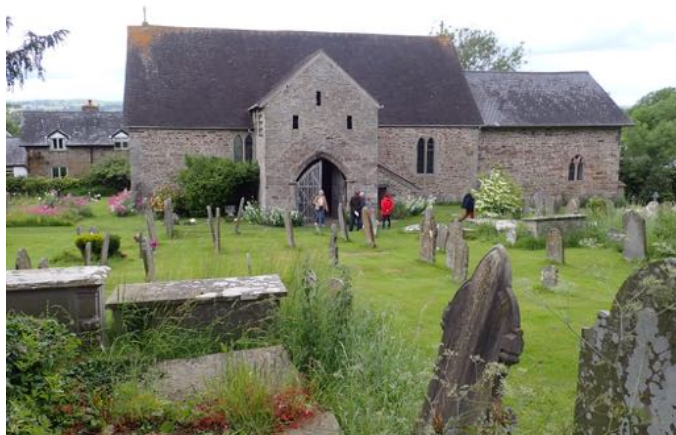
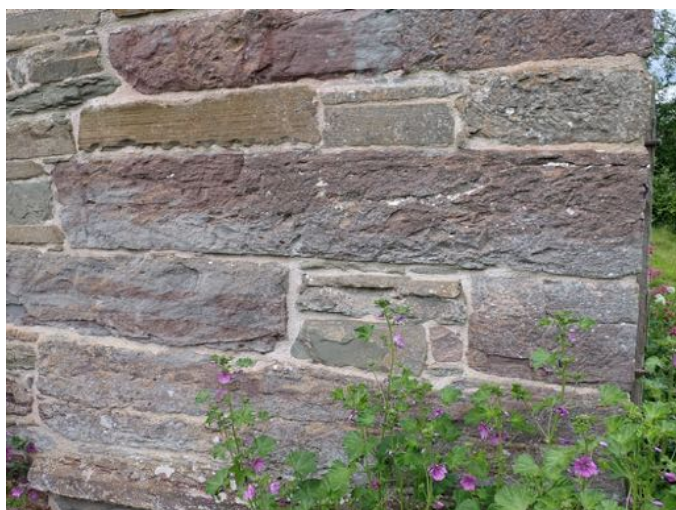
Fig. 10 (top) St. Eigon's church, Llanigon. Fig. 11. (bottom) large slabs of grey/maroon sandstone, south chancel wall.

After lunch in Talgarth, the group made the final stop of the day at **St. Eigon's Church Llanigon** (Fig. 10) set in as circular churchyard. The church is composed of a nave, chancel, south porch with a small lean-to on its east side,

The fabric was again seen to be of local sandstone. Most commonly this is as small to medium sized slabs and blocks of red and grey sandstone, but a mix of different sandstones, some coursed, some fine-grained, regularly shaped but randomly coursed is present. The nave south and east walls however, show significantly longer (up to 70cm) blocks of grey and red banded sandstone (Fig. 11). Occasional blocks of pebbly sandstone and calcrete were also found (Figs 12 & 13). Such pebbly sandstones have been recorded from the base of the SMF, in adjacent Herefordshire, (English Heritage, 2012) and such a source would be consistent with the presence of calcrete blocks. A major calcrete horizon (Bishop's Frome Limestone Members) sits just above the base of the RMF and SMF.

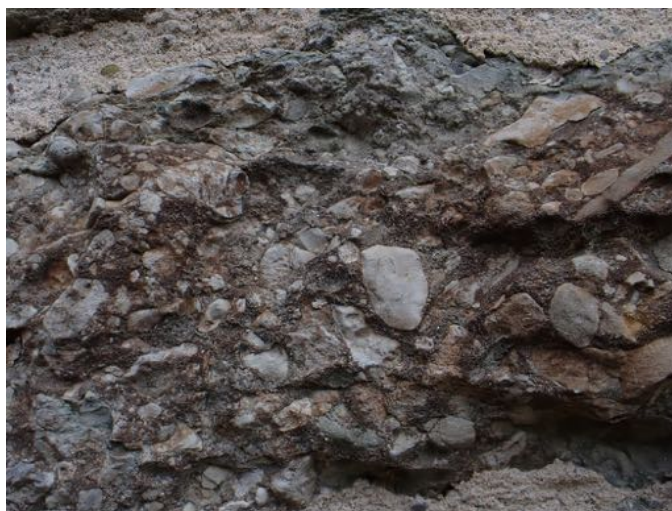
Fig. 12. Calcrete block is rubblework. Fig. 13. Close up of Fig. 12 showing the texture of the carbonate nodules.

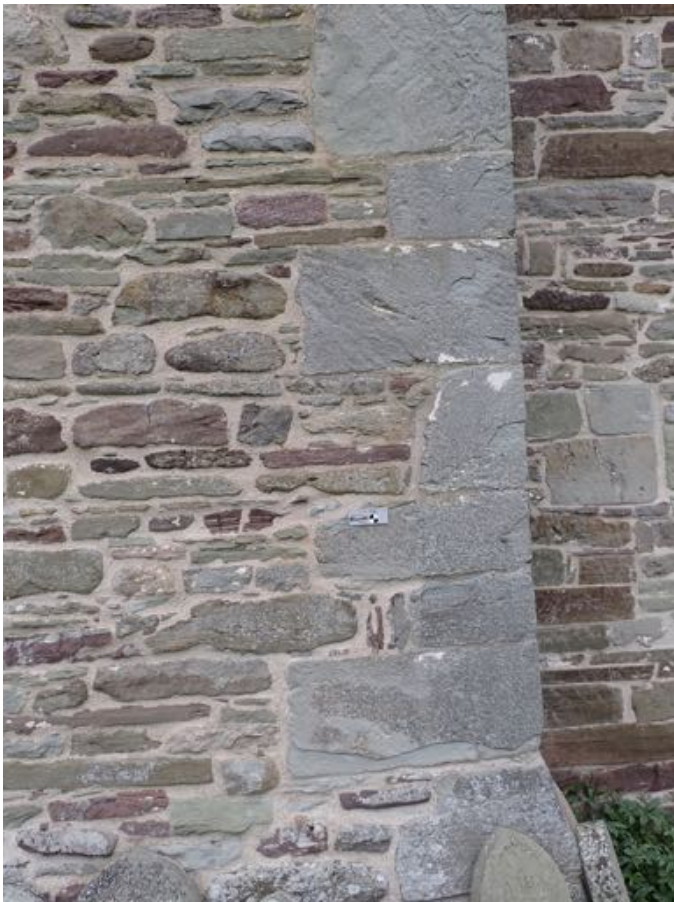
Fig. 14. Grey homogenous sandstone quoins, SE nave, inserted during C19 restoration work.

pillars at Llanddew, was seen as quoins in the south wall of the nave, but here its use dates from the C19 restoration. . The 'new' (C19) font was then examined and Tim Palmer confirmed this to be of Painswick Stone, from near Stroud, Gloucestershire 9 (Fig. 15). He also reminded the group of the key features of Painswick Stone. The old font was then viewed in the porch (Fig. 16). Inspection of this showed it to be of pebbly sandstone a discussion followed as to whether this was derived from the SMF or from a pebbly unit in the overlying Brownstones Formation (BF). John Davies, who has made a study of the pebbly facies within the BF, suggested that this was from that formation rather than the SMF. The similarity of sandstone textures within the Lower Devonian, emphasises the difficulty sometimes encountered in that assigning a specific formation as a sources.

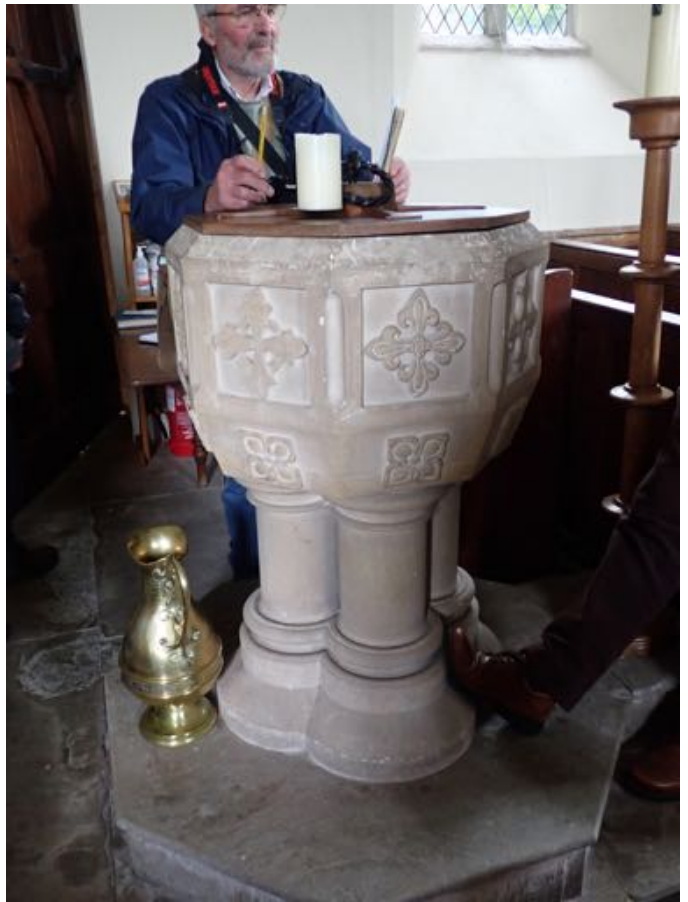
Fig 15. (top) John Shipton guarding the C19 font worked from Painswick Stone. Fig. 16, (bottom) the 'old' (C13) font of pebble red sandstone.

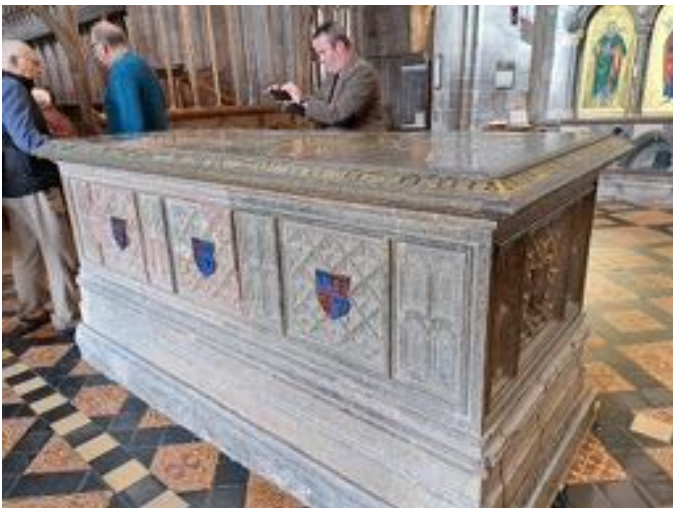
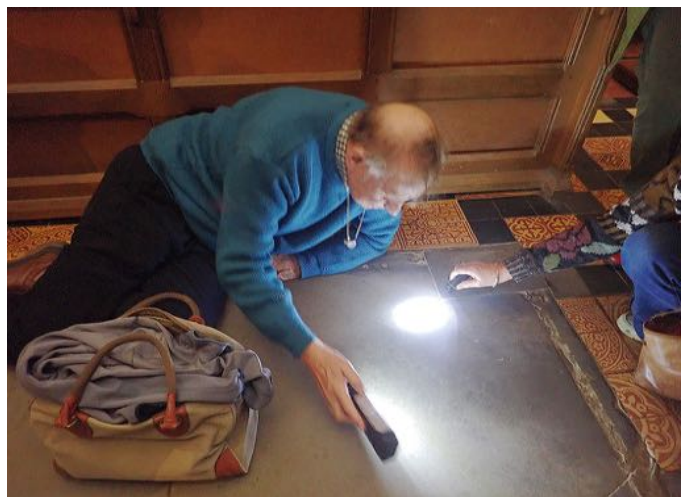
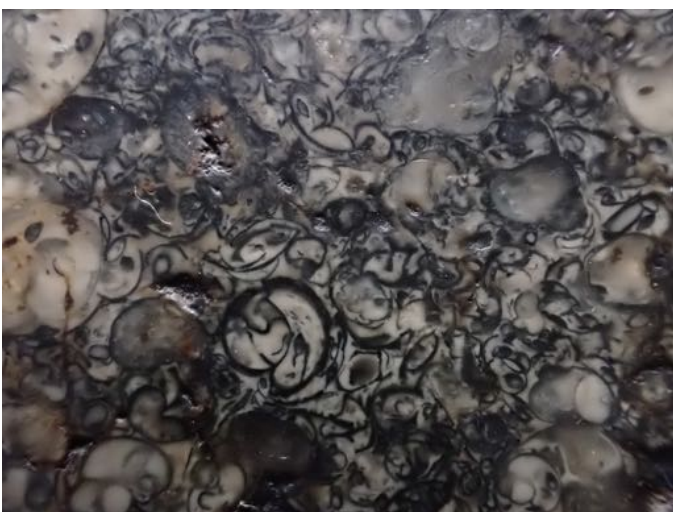
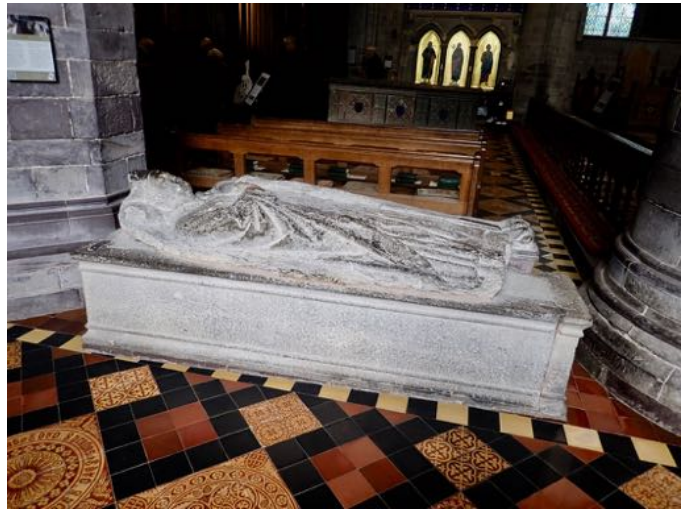
Fig.1 (top left) Edmund Tudor tomb chest showing polished Purbeck Marble top and variably coloured Marble side panels. Fig. 2. (bottom left) close up view of Purbeck Marble showing whole and fragments of *Viviparus* gastropods shells. Fig. 3(top right). Tim Palmer inspecting ?Nolton Stone slab in the choir stall. Fig. 4. (bottom right) effigies of Bishops Iorwerth and Anselm both worked from Lower Jurassic Blue Lias limestone.

the tomb (Fig. 2). The Purbeck stone varies in colour and different levels of polish, depending where it was located within the tomb. It is possible that some of the more weathered slabs had been replaced by Scott.

stone, where ooids fall away forming an ‘egg-cup on the tray’ structure (Palmer, 2008). Similar close examinations were made of the adjacent 13th century effigies of Bishops Iorwerth and Anselm both worked from Lower Jurassic Blue Lias (Fig. 4). Tim observed subtleties in the Lias (the apparent abundance of bivalved mollusc burrows), possible suggesting that the base of Iowerth’s tomb (rear tomb) and all of Anselm’s, were worked from similar Lias horizons with the Iowerth’s effigy worked from a different horizon.

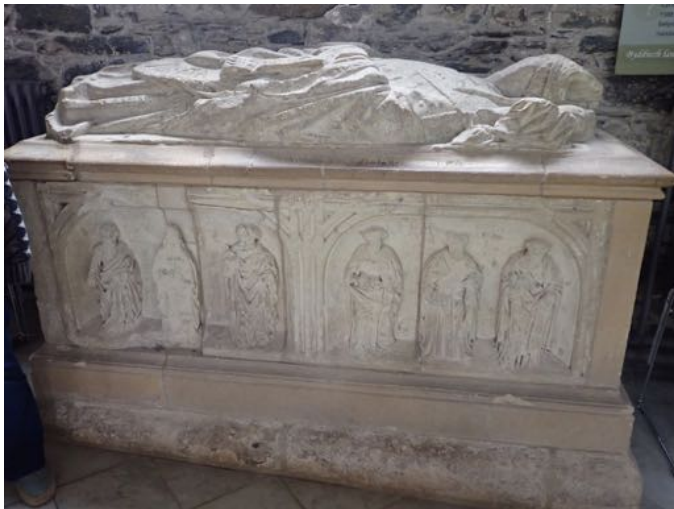
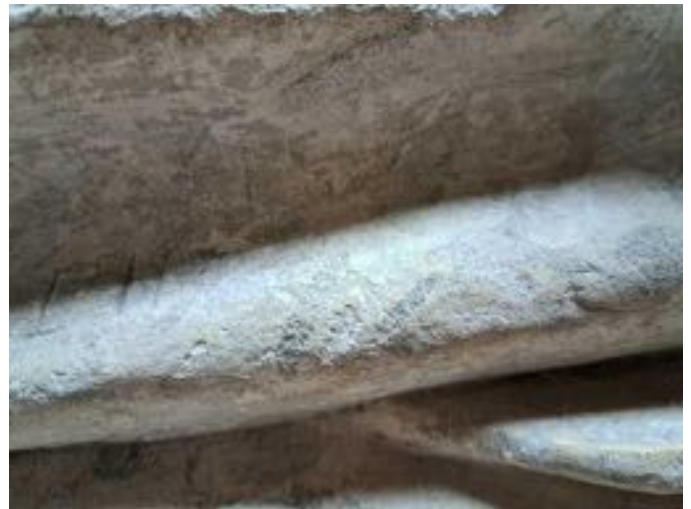
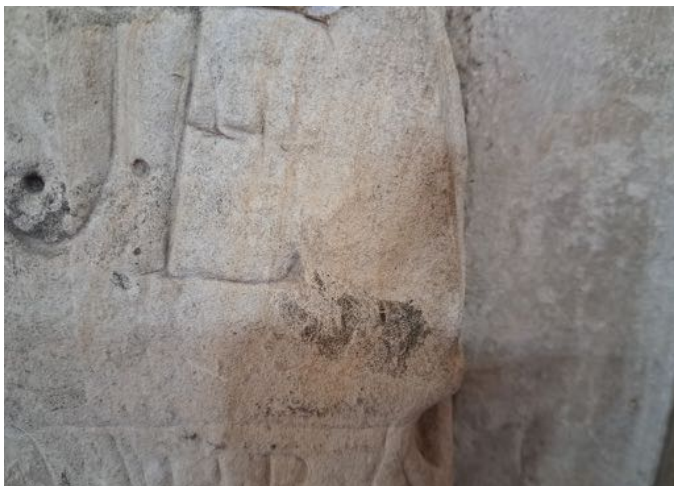
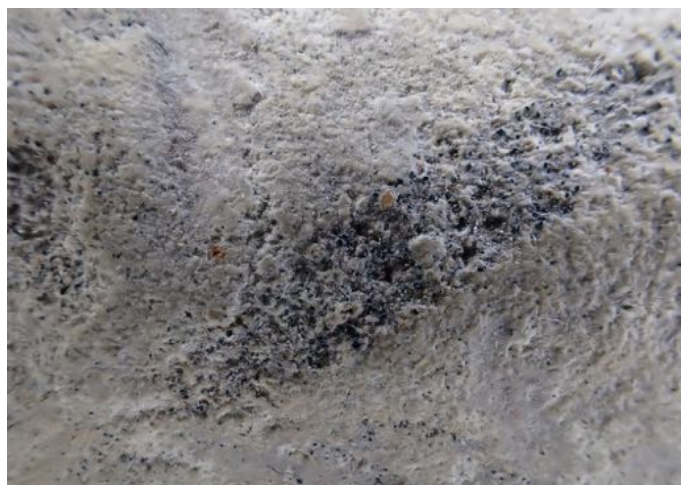
Fig.5 (top left) tomb of Bishop John Morgan, craved from Beer Stone. Fig. 6 (bottom left) close up of Beer Stone chalk texture. Fig 7 (top right) Characteristic burrow structures in Beer Stone. Fig. 8 (bottom right) close up of dark glauconite grains in burrow.

and lower beds in the Beer stone sequence. Minor repairs to the tomb had been executed in Bath stone.

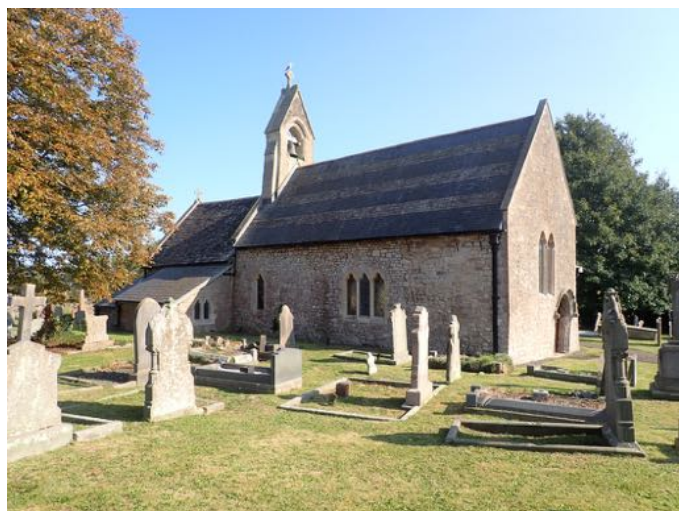
Fig. 1. St Mary's church Undy, viewed from northwest.

a simple structure comprising a chancel, nave and south porch, and originates from the C12 (Newman, 2000). The tower was removed during renovation in 1878 and replaced with a bellcote (Fig.1).

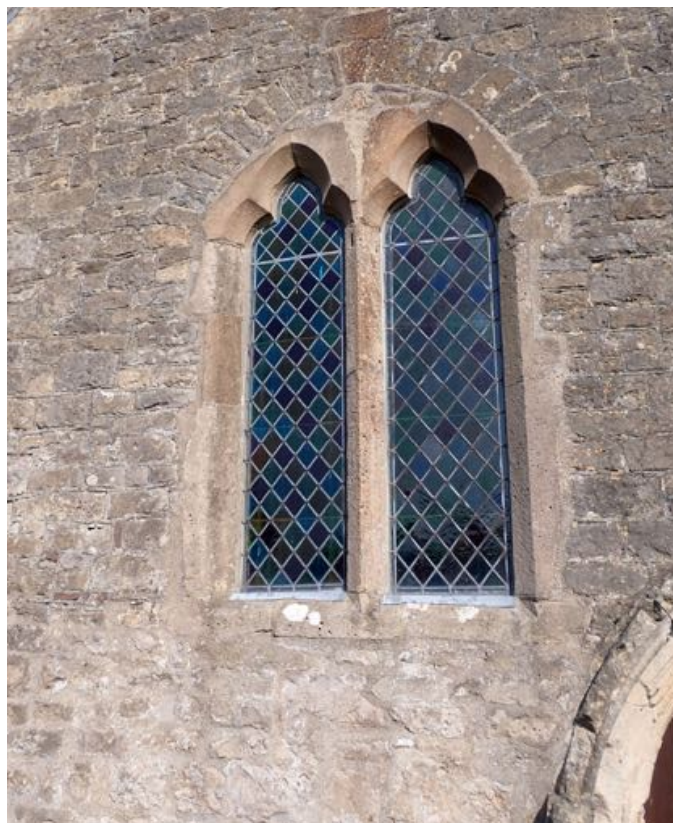
Fig.2. Dolomitic Conglomerate window in west wall.

The group viewed the west wall. The two-trefoil lancet window c. 1300 (Newman, 2000) which provides an example of the medieval use of buff Dolomitic Conglomerate (Fig. 2). It contains angular limestone fragment, mostly less than 5mm, but some up to 25 mm and is similar to the medieval Dcg seen at Redwick (Newsletter, 20). This stone is seen again in the doorway at the east end of the south wall (although this doorway shows repairs in Bath Stone) and in the later Perpendicular south window, and Tudor east window. From this it can be concluded that Dcg was the stone used for dressings prior to the C19 renovations work.

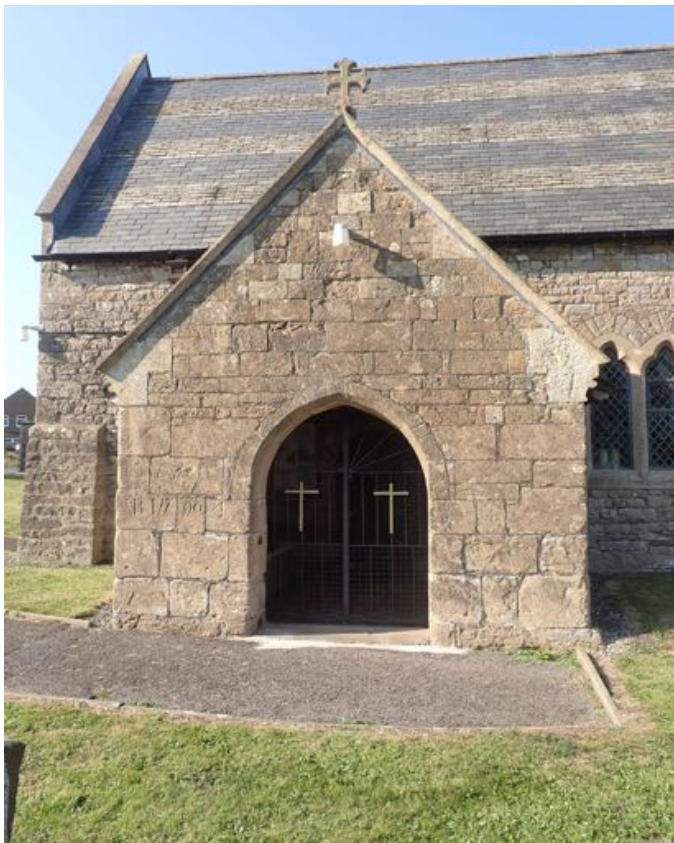
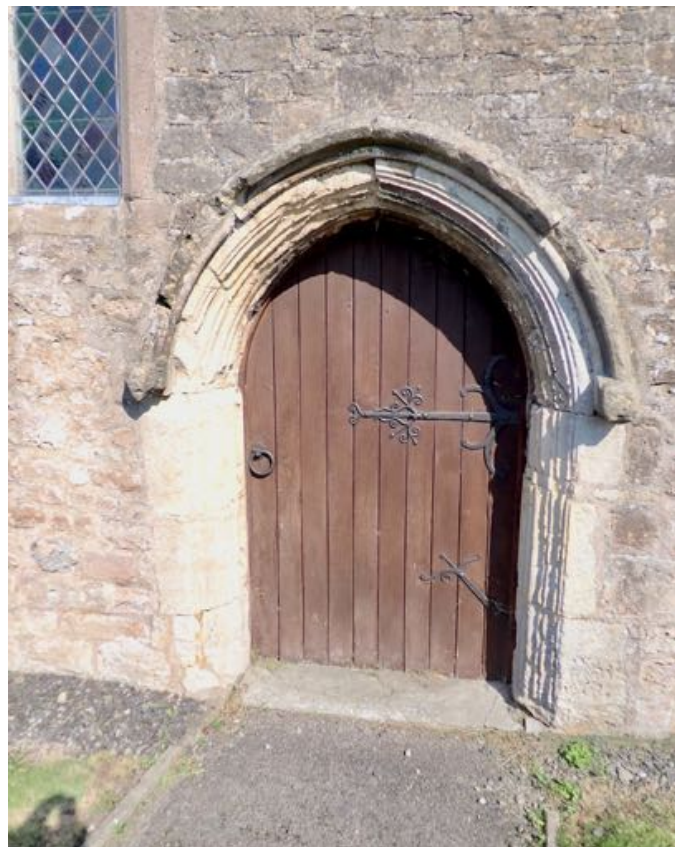
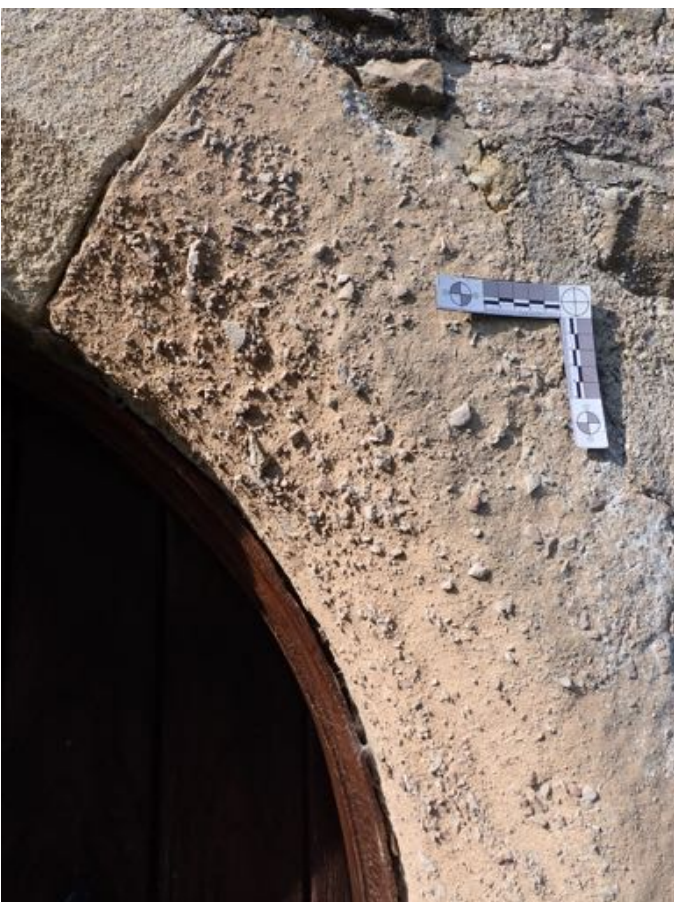
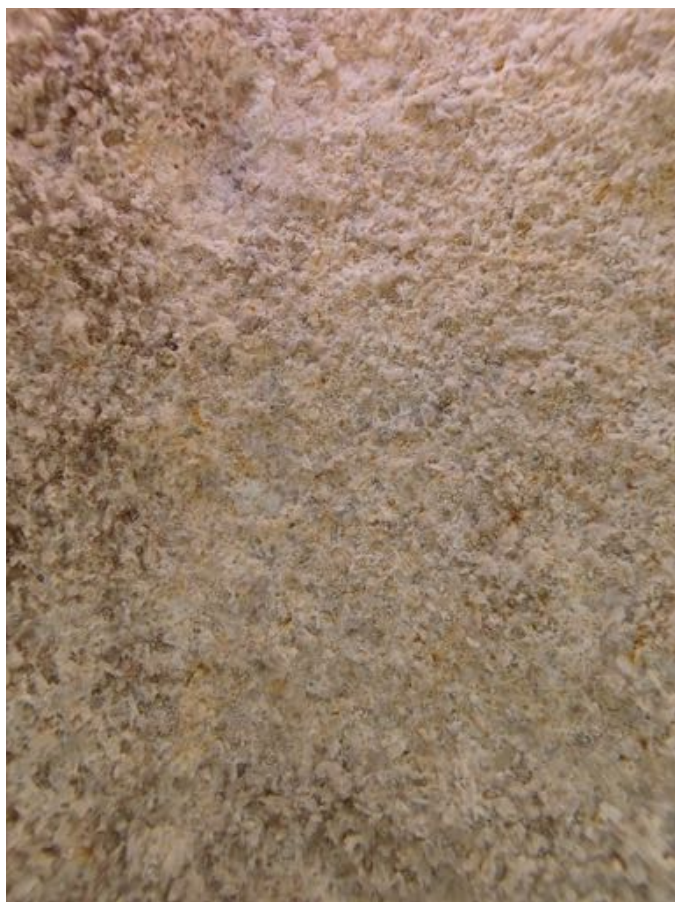
Fig. 3. (top left) South porch of ashlar Dolomitic Conglomerate. Roof of nave behind displaying two shades of grey slate. Fig. 4. (bottom left) Dolomitic Conglomerate from porch ashlar, showing slightly smaller clasts than stone used in earlier medieval dressings. Fig. 5. (top right) West doorway worked in Dundry Stone. Fig. 6. (bottom right) Close up of Dundry Stone in Fig. 5.

These examples of medieval use of Dolomitic Conglomerate contrast with that seen in the porch (Fig. 3), which was added in 1790. It is constructed from ashlar blocks (c. 40cm -50cm x 40cm) with relatively smooth faces. This seems to be the latest date for the use of the stone that we have noted in Monmouthshire. A notable feature of this stone is the presence of cavities (vugs), typically up to 10 mm in diameter, lined with white crystals of calcite. Some larger lithic fragments up to

The only medieval 'imported' stone noted at St Mary's was seen in the west doorway (Fig. 5). This dates from the c. early C14 (Perpendicular) with multiple shallow

moldings. Newman (2000) considers this strangely located on the south edge of the wall and 'oddly handsome for this simple building', implying that this may not have been made for this location but was relocated from a more prestigious building. Examination confirm that this is worked from Dundry Stone, supporting a possible recycled origin and a later insertion, as no other Dundry was noted in the building (Fig. 6).

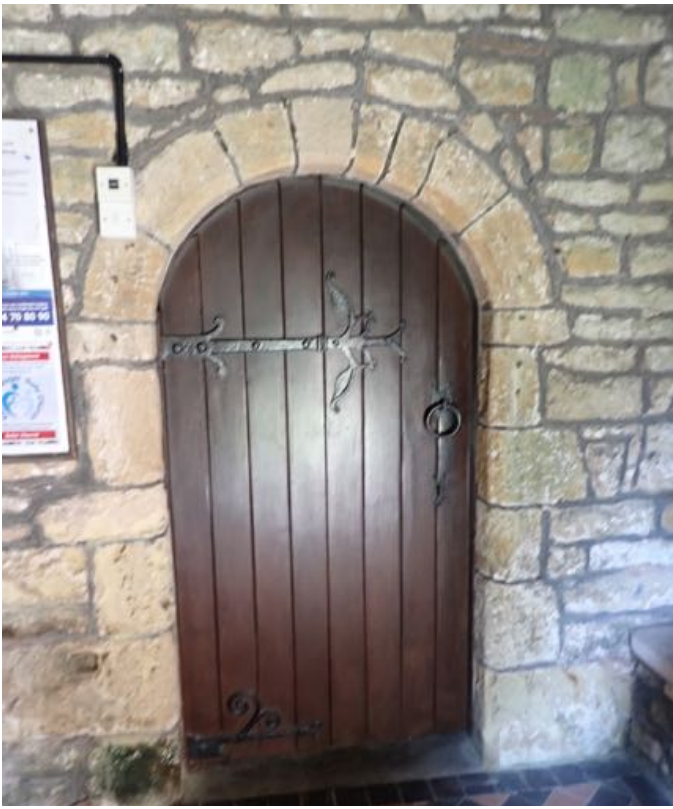
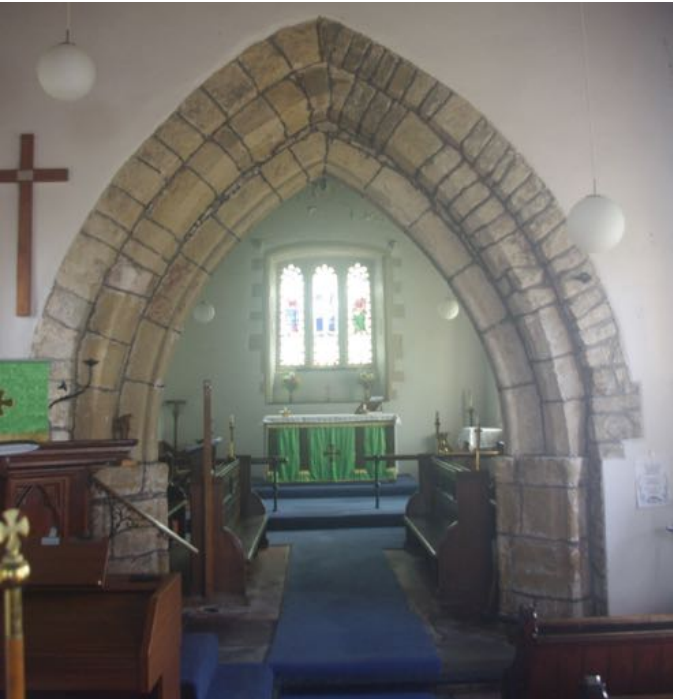
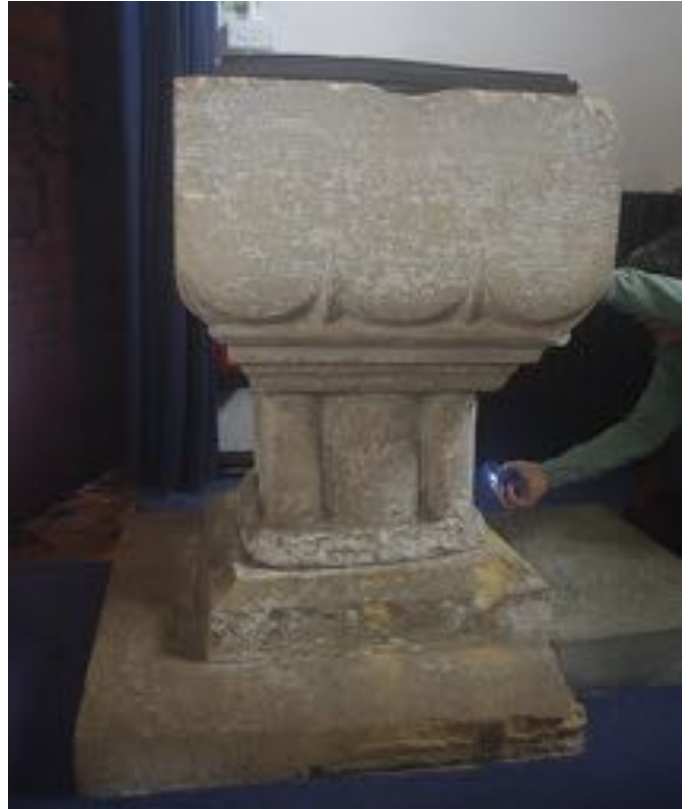
Fig. 7. (top left) south doorway of Dolomitic Conglomerate with some replacement by Bath Stone. Fig. 8. (bottom left) Chancel arch of Sudbrook Stone, stone on middle left shows characteristic yellow/red mottling. Fig 9. (top right) square, C12, font of Sudbrook Stone.

Inside the church, of note are the south door, chancel arch, and the font. The south door was examined and was seen to consist of original Dolomitic Conglomerate, but with jambs replaced on the left-hand side in Bath Stone (Fig. 7).

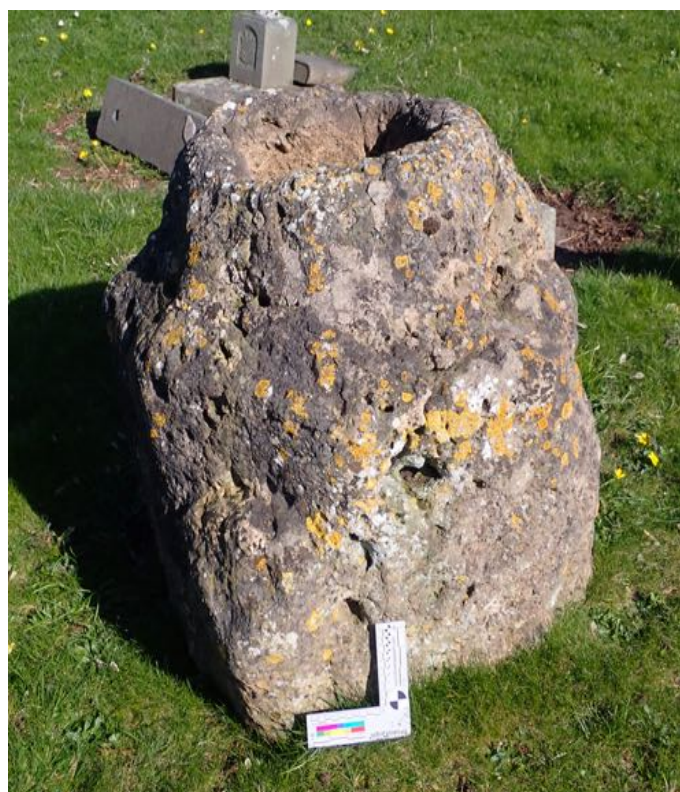
Fig. 11. (top) Medieval socket stone, Dolomitic Conglomerate.
Fig. 12. (Bottom) Stepped base (Tintern Stone) and socket stone
?Dundry

The visit started with an examination of two cross bases in the churchyard, both of unspecified medieval ages. The smaller of the two (Fig. 11) is a large socket-stone 'some 0.76m square by 0.77m high with large broached (or "bull-nosed") stops. The top of the stone is chamfered with an unusual octagonal socket, off-set to the north-east' (Cadw scheduling citation). Examination rapidly identified this as being worked from Dolomitic Conglomerate, with grey angular clasts of Carboniferous Limestone. The larger base (c 2.72m square) with three steps was viewed next (Fig. 12). The lower two layers were clearly different being shaped blocks of coarse quartz arenite containing white quartz pebbles (up to 20mm) and pink quartz grains. Jana indicated that this was Devonian in age and attributed it to the Tintern Sandstone Upper Devonian sequence. On top of this sits a socket stone. This proved a bit more of a challenge to the group, the composition not being easily determined as it was extensively coated by lichen. A small area, in a most inconvenient place to access, showed a pale, fine-grained bioclastic, non-oolitic, limestone resembling Dundry Stone. However, Tim Palmer was a little uncertain if this was Dundry *sensu stricto*, he also suggested that this could be a re-worked Roman altar.
