Number 21, 2025

Welcome to the Welsh Stone Forum Newsletter 21. Although the Forum had a slightly reduced programme for 2024, in part as a product of the cuts to Mineralogy & Petrology section staff at Amgueddfa Cymru - National Museum Wales, I hope that you still enjoy the reports and articles. Thanks are due to all those involved in planning and leading these events. We have held joint meetings with other societies in the past, and our joint meeting for 2024 was a study day in October with the Church Monument Society at St David's Cathedral. This provided an excellent opportunity to view and discuss the interior of the cathedral with those with complimentary interests and knowledge. An enjoyable time was had by all! Although the CMS activity is not exclusively in Wales, we hope that a similar day might be programmed with them in the future. We would like to thank Heather James of the Society for producing such an excellent report of the day.

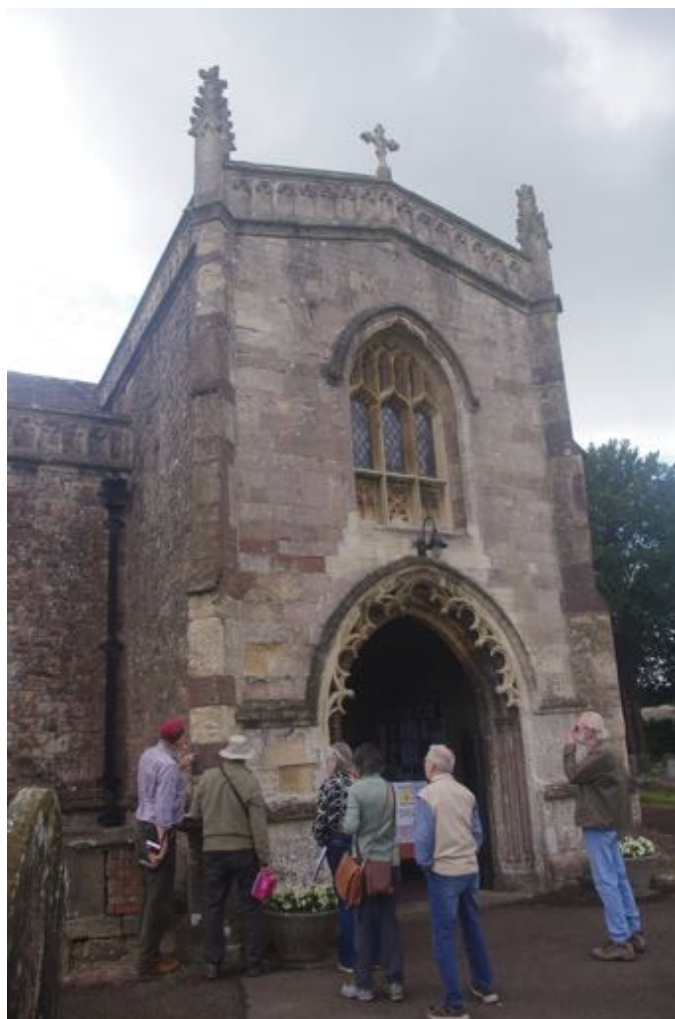
Fig. 13. Porch, St Mary's Magor. Window, outer arch of doorway, and replaced stone below window, Bath Stone. Ashlar; Dolomitic Conglomerate, Dundry Stone, Sudbrook Stone, with minor red 'Tintern Sandstone'.

Moving on to the body of the church, the porch (either C14 or C16!), located on the north side was examined first. The pleasing ashlar façade was seen to contain blocks of Dolomitic Conglomerate (Dcg), Dundry and Bath stone, with the diagonal buttresses to the east and west a mixture of Dcg and 'Tintern Sandstone' (Figs 13 & 14). The window (inaccessible) was clearly replaced during C19 renovation, so assumed to be of Bath Stone. The fabric of the porch, although appearing red (described by Cadw as 'of rubble red sandstone'), was seen to be dominated by

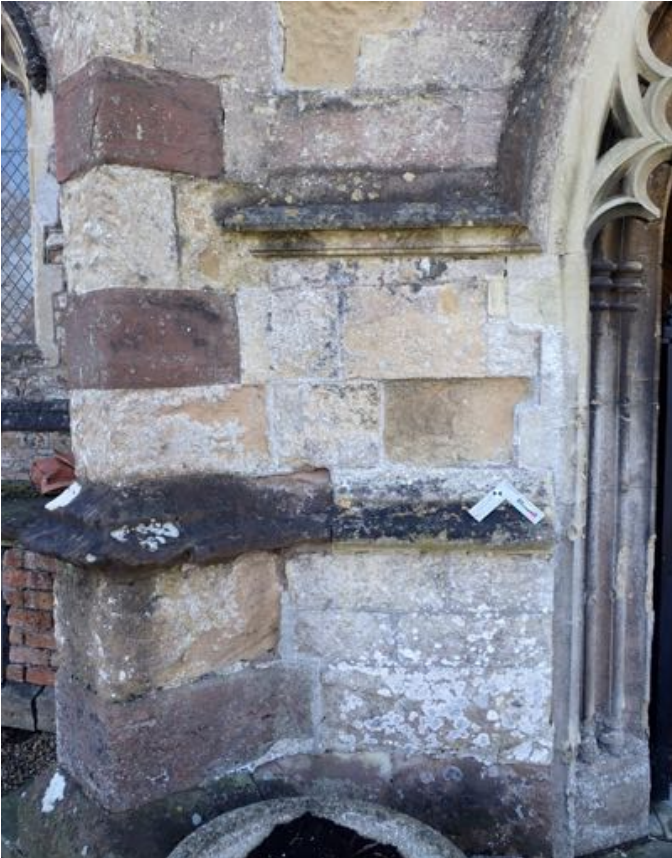
Fig. 14. Close up of stone in porch buttress. Red = Tintern Sandstone, yellow = Dolomitic Conglomerate, Cream = Dundry Stone. Doorway Bath Stone.

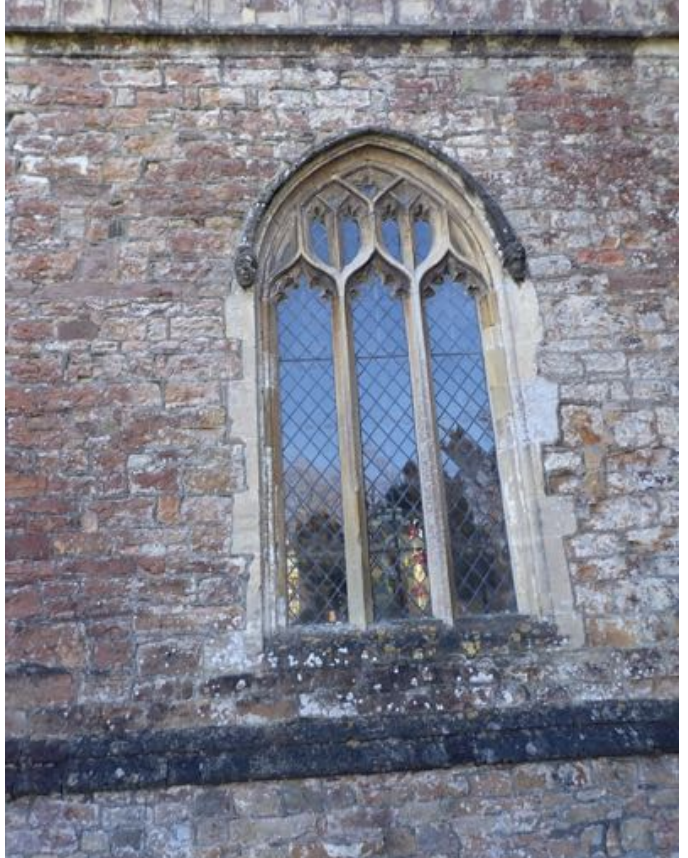
Fig. 16 (bottom) north wall of nave with C14 window of Dundry Stone, with replaced tracery and mullions.

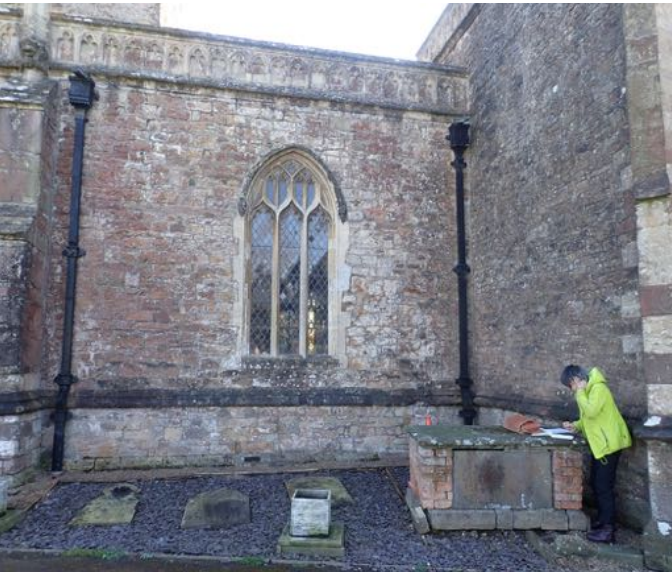
Fig. 15 Nave, fabric dominantly Carboniferous Limestone, locally reddened by a coating of algae, string course of Tintern Sandstone and battlements of ? Dundry Stone.

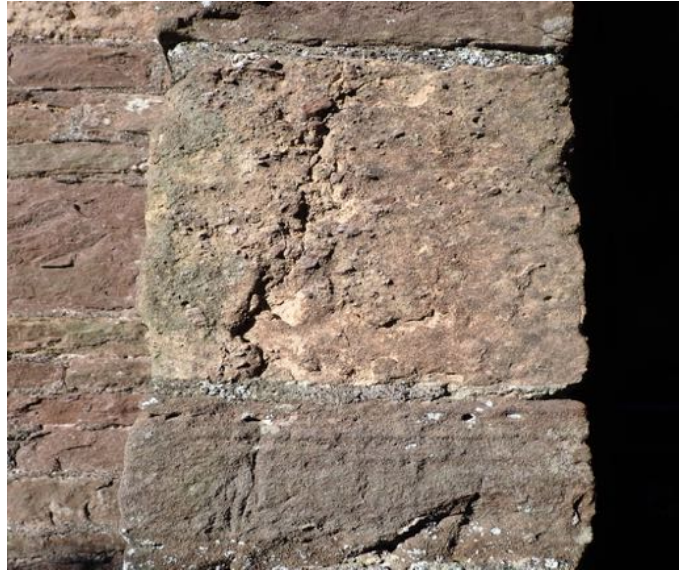
Fig. 17. buttress in south nave composed of blocks of Tintern Stone and Dolomitic Conglomerate.

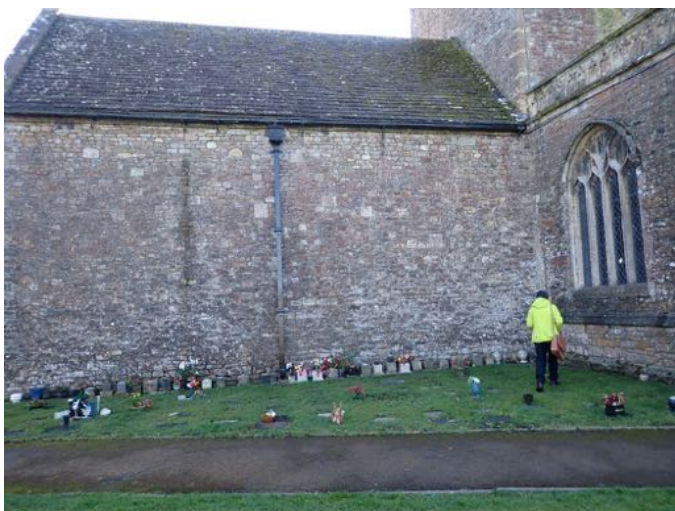
Fig. 18. Windowless north chancel wall showing a variety of stone, including squared blocks of ?Dundry Stone. Stone tile roof also well displayed.

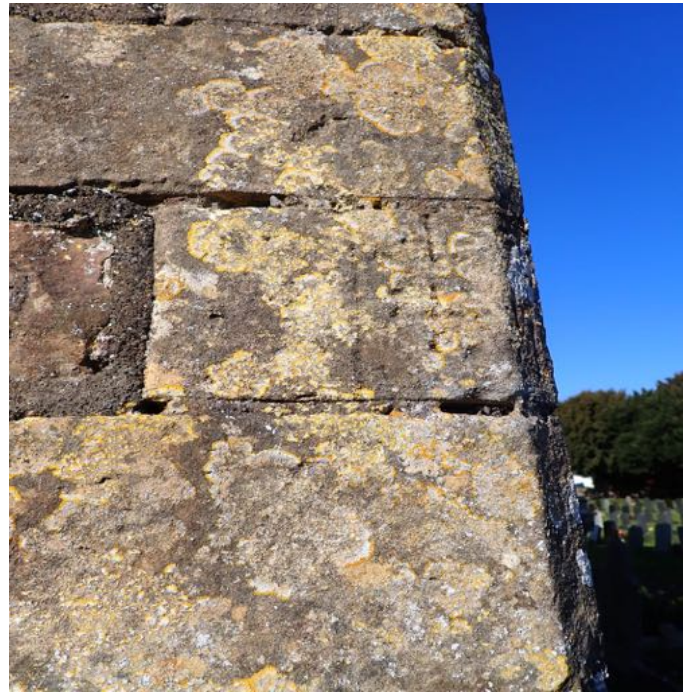
Fig. 19. SE corner of chancel showing Dundry quoins with cross marking.

The lower quoins are dominantly of Sudbrook Stone or Tintern Sandstone, but those above are of Dundry Stone. In one of the Dundry quoins at the east end of the south wall, incised crosses were found, which it has been suggested are crusader crosses (Fig. 19). Below this stone

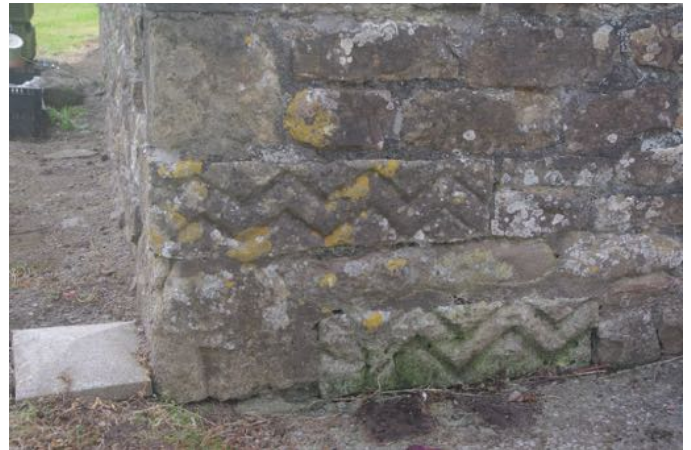
Fig. 20.. Two stones with zig-zag carving at east end of north chancel wall.

and again on the east corner of the north wall, stones with zig-zag carving, were noticed.(Fig. 20). There are heavily covered with algae but were thought to be worked from Sudbrook Stone, although the sharpness of the carving on the south wall stone suggests Dundry Stone. Newman (2000) considers that these originated from an earlier C12 phase of building, and the group observed that these are reminiscent of the stone (C12) at St Mary's Magdelene, Goldcliff, similarly inset into a later (C15) fabric. As with the main porch window, the chancel east window was reconfigured and replaced in Bath Stone by J. Nolton. The only original medieval chancel window, seen was the South wall, early C14 quatrefoil window (Newman, 2000). Examination identified this to be a combination of Dgc and Dundry, with a Dundry sill (Fig. 21). The relieving arch above solicited further discussion, but the composition of the smooth pales stones was not agreed on. Possibly these are Dundry too. Dundry was seen again in the doorway adjacent to this window, although with

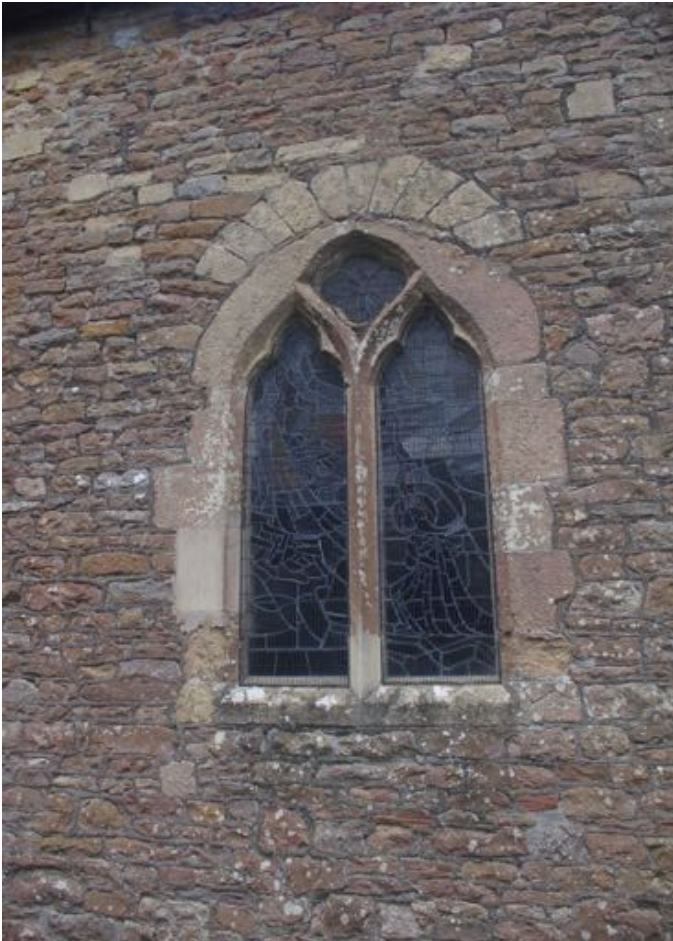
Fig. 21. C14 chancel window of Dolomitic Conglomerate and (later replacement?) Dundry Stone.

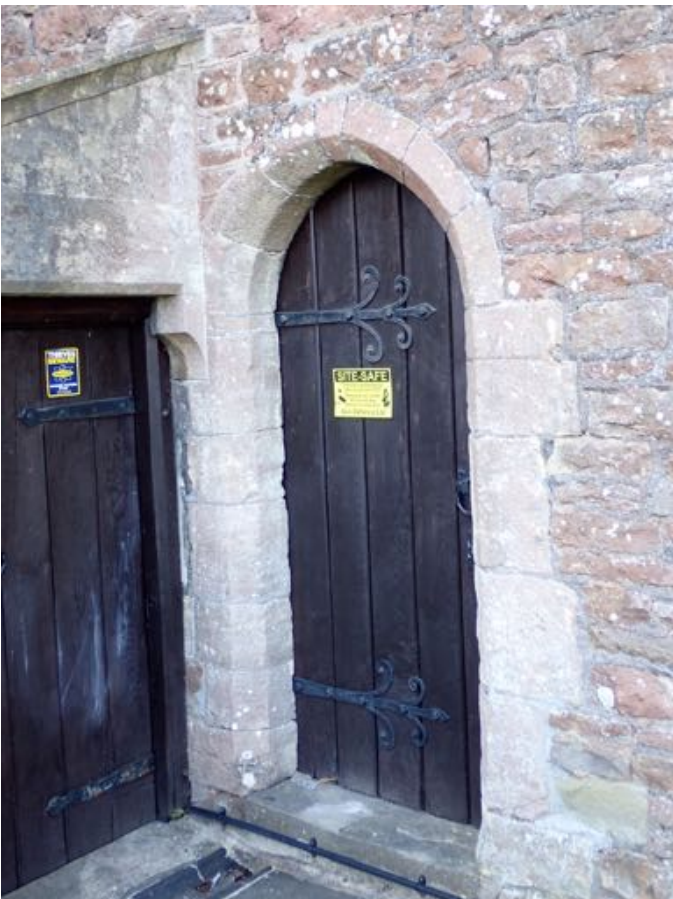
Fig. 22. Dundry Stone doorway in south wall of chancel with Sudbrook Stone in 1 and 2 o'clock positions.

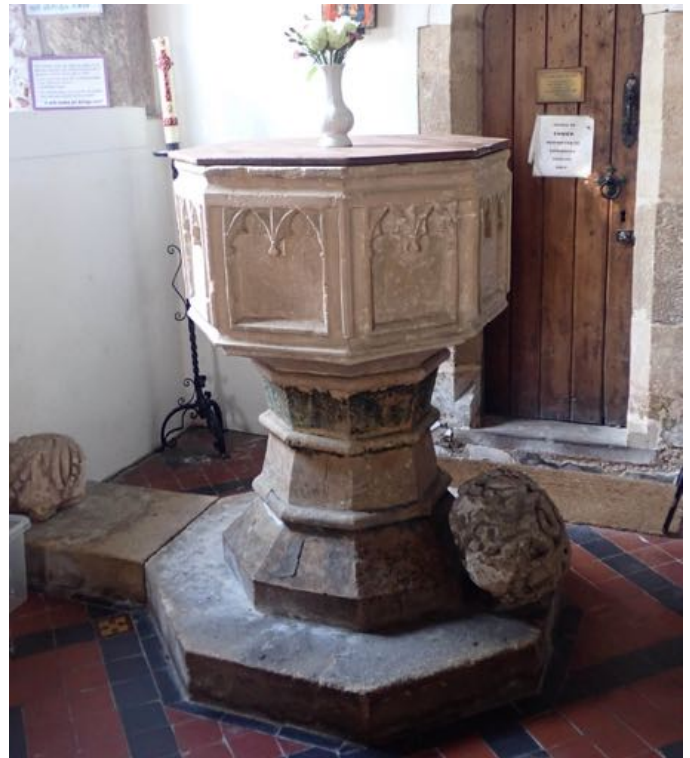
Fig. 23. Dundry Stone font with C19 Bath Stone repairs.

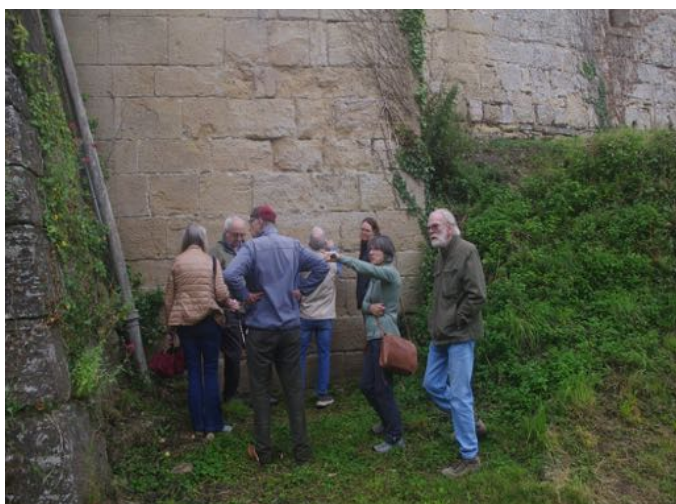
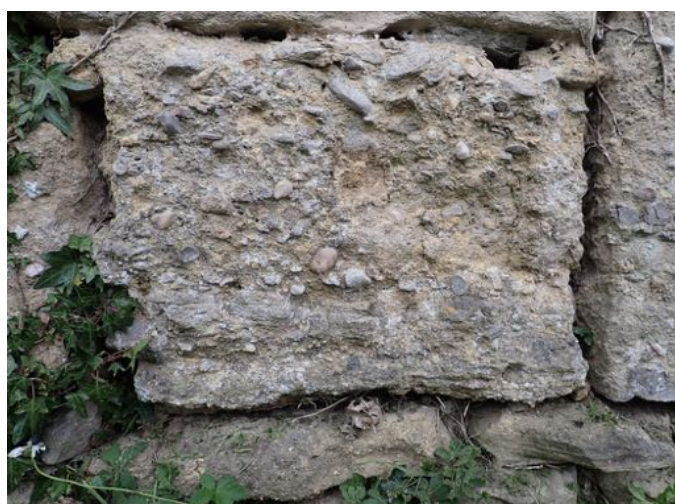
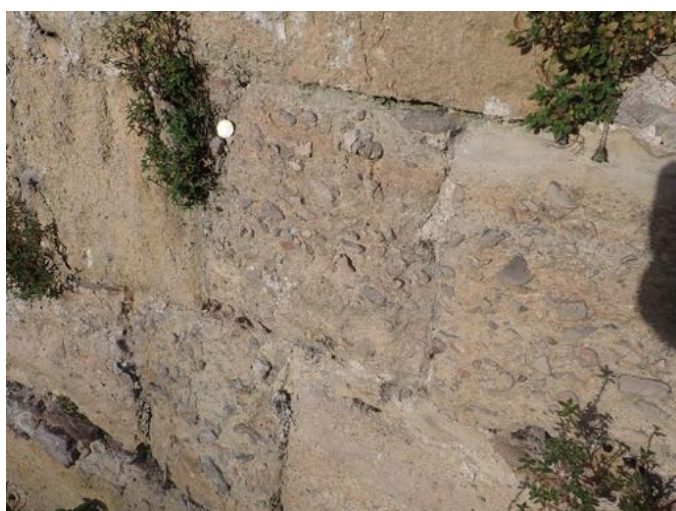
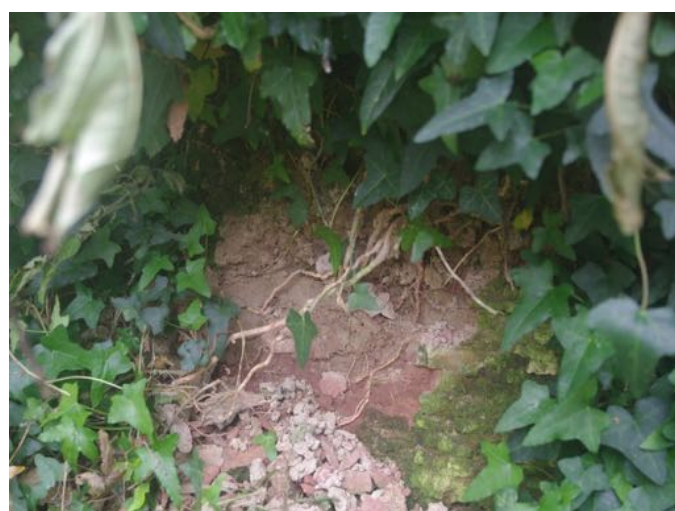
The group first examined the main Gatehouse on the south side of the castle, which was seen to be of fine ashlar, 'typical' Sudbrook Stone (Fig. 24). The curtain wall to the east of the gatehouse is composed of large, coursed blocks. On the basis of the structure of the masonry, there was a discussion as to whether this part of the wall, although included in the same phase of building, may have pre-

Fig. 24. Ashlar blocks of Sudbrook Stone, in main Gatehouse. Fig. 25. Detail of blocks, showing some to be conglomeratic with coarse angular fragments of limestone. Fig. 26. Block in Gatehouse showing rounded and angular clasts. Fig. 27. Small exposure of Dolomitic Conglomerate, to the west of the Gatehouse, containing angular and rounded clasts

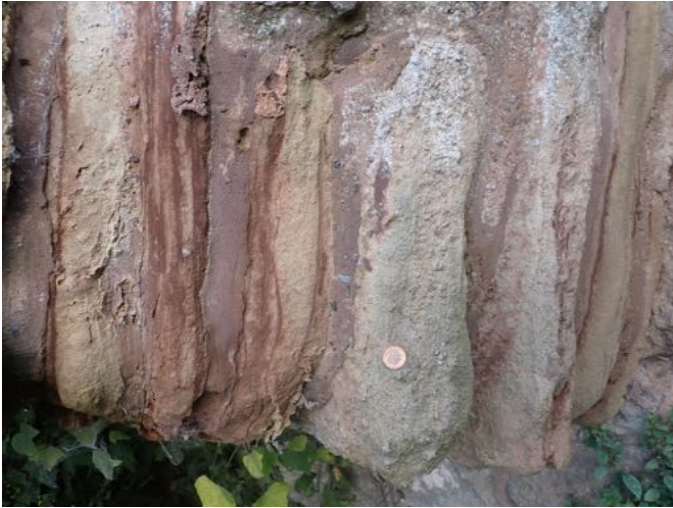
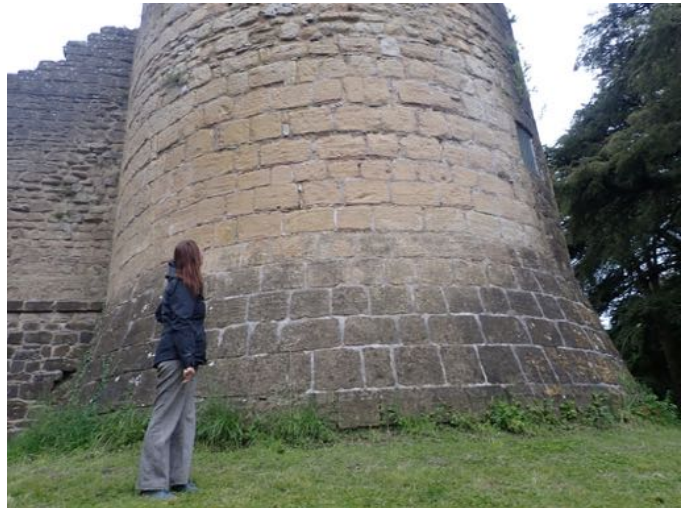
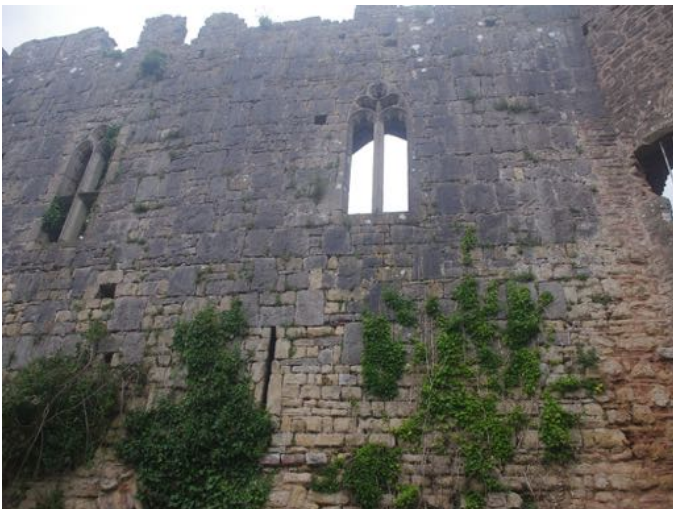
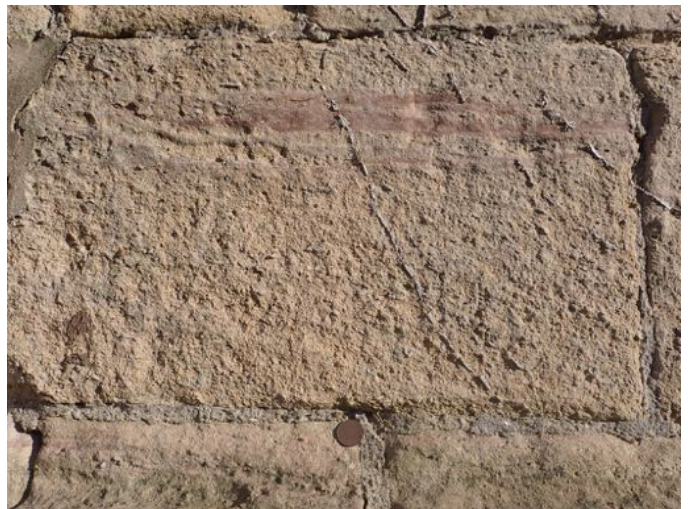
Fig. 28. (top left) Banded yellow and red Sudbrook Stone in arch on S curtain wall. Fig. 29. (top right) Curtain wall by SE tower, showing base composed of Sudbrook Stone (yellow) and upper courses in Carboniferous Limestone (grey). Fig. 30. (bottom left) Coursed blockwork of Sudbrook Stone (SW tower), colour variation a product of battered structure of wall catching greater moisture. Scale provided by our new Treasurer, Heather Jackson. Fig. 31. (bottom right) Close up of Sudbrook Stone showing mottling produced by lense of finer red sand.

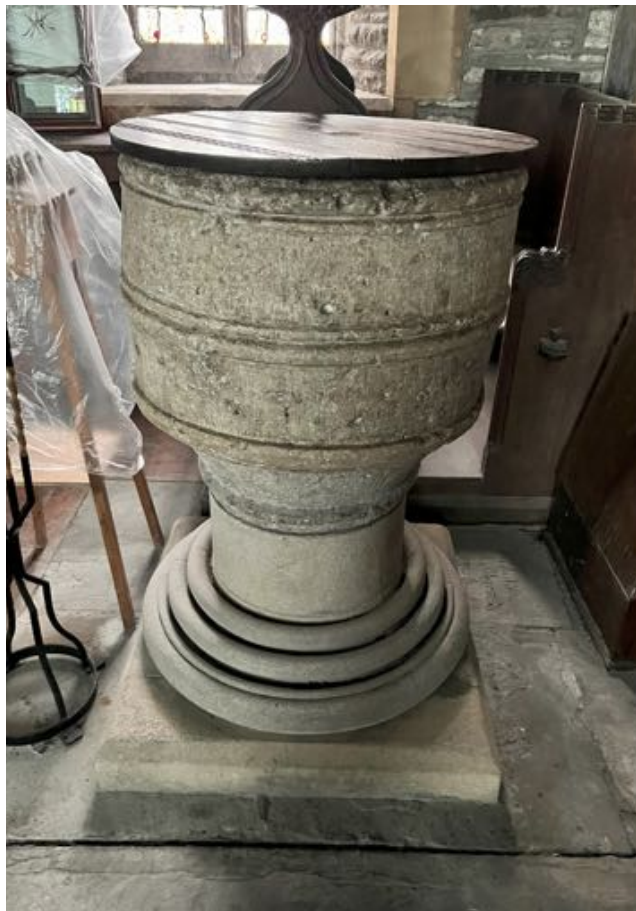
*St Gwynno, Llanwonna, Rhondda Cynon Taff.
Medieval (thought to be C14) Sutton Stone font.*
